SMOKE, FIRE AND FUMES IN TRANSPORT AIRCRAFT

PAST HISTORY, CURRENT RISKS AND RECOMMENDED MITIGATIONS

Part 2: Training

A Specialist Paper by the **Royal Aeronautical Society**

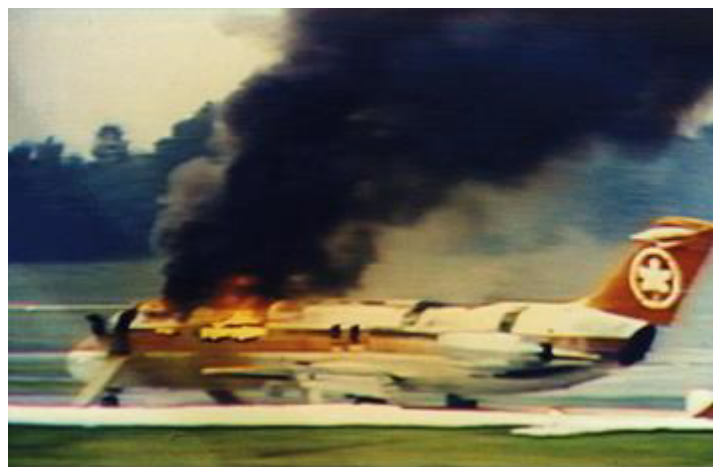
DC-9 accident – Cincinnati June 1983

In Advisory Circular (AC) 120-80A – In-flight Fires (FAA, 2014), the FAA identified that the time for the situation to become non-survivable was as little as seven minutes, and that only in one third of hidden fire events would the aircraft reach an aerodrome before the fire became uncontrollable. An example of this is the accident involving an Air Canada DC-9 which diverted to Cincinnati in June 1983 when a lavatory compartment fire became uncontrollable (NTSB, 1986).

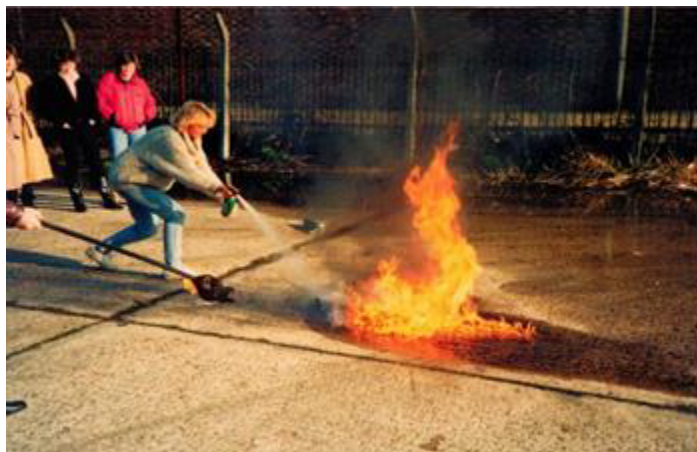
During training in the 1980s, aircraft crew usually fought fairly large fires in the open air. At that time oil tray fires were favoured and Halon could be used. These fires were usually quite large and challenging. They could be difficult to extinguish unless the correct procedure was used, such as aiming the extinguisher at the base of the flames. Re-ignition was often a major factor. While a fire of such size would be most unlikely to occur on a commercial aircraft, it did provide an awareness of the problem and also the effectiveness of Halon.

Practical fire training in the 1980s

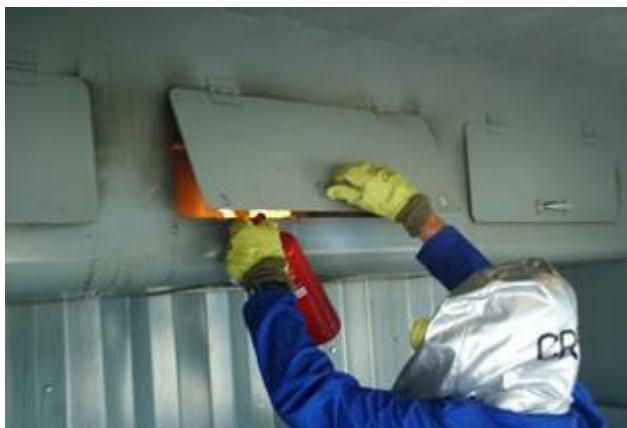
Combining fire extinguisher training with PBE training is certainly feasible since some operators and training organisations achieve both elements in one practical fire training scenario. Therefore, regulatory requirements should reflect the likelihood of an in-flight fire in which different items of fire safety equipment need to be used simultaneously. Attempting to meet practical fire training requirements in unrealistic, separate fire training scenarios is not satisfactory.

Combining fire extinguisher training with PBE training & fire gloves
